River City Inspection LLC

CONFIDENTIAL INSPECTION REPORT

503 Red Baron Dr, Shreveport, LA 71115

10/5/2015 9:00 am to 11:00 am

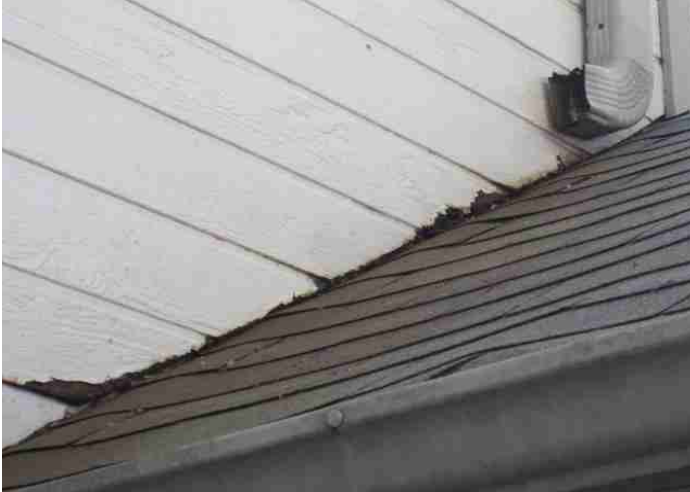
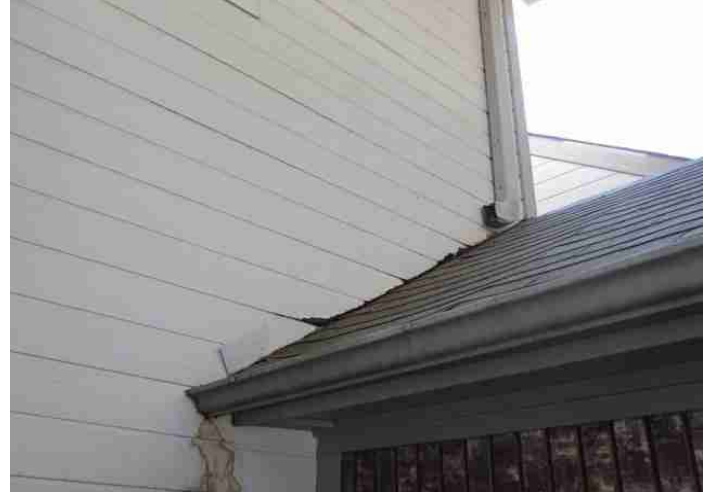
There are sections of the siding in need of repair. These are primarily located along the bottom of the siding.

The photos are representative of the damage but we may not show all of the areas needing repairs.

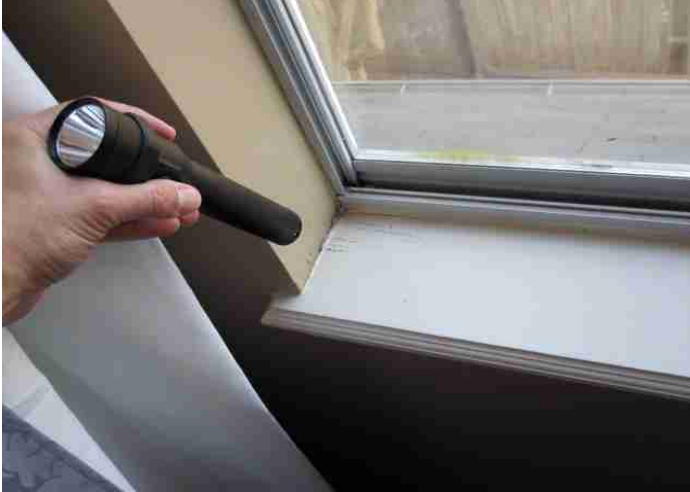
The interior window casings and sills have typical moisture damage from condensation. This home has aluminum windows installed. In the winter moisture condenses on the window can then pool on the interior sheet rock casing and wood window sill. Over the years this will cause deterioration, to the sills and window casings. Window coverings such as shutters and drapes will accelerate this deterioration. I recommend that you view all of the interior window casing and sills in the home once so you can make sure that the condition suits you. This should be done while in your inspection period as you may wish to have these areas repaired and the costs associated with said repairs may affect your overall evaluation of the property.

Note that I do not show a photo of every deteriorated window in the home. Photos are representative of the damage found and I recommend you view each window to ensure they will suit you and your families needs.

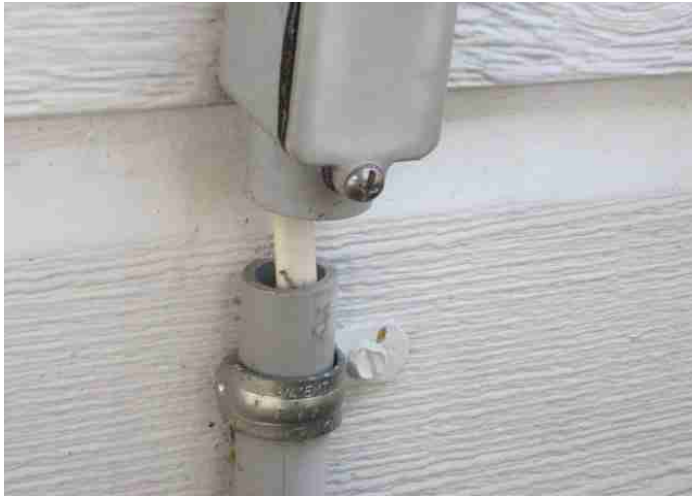
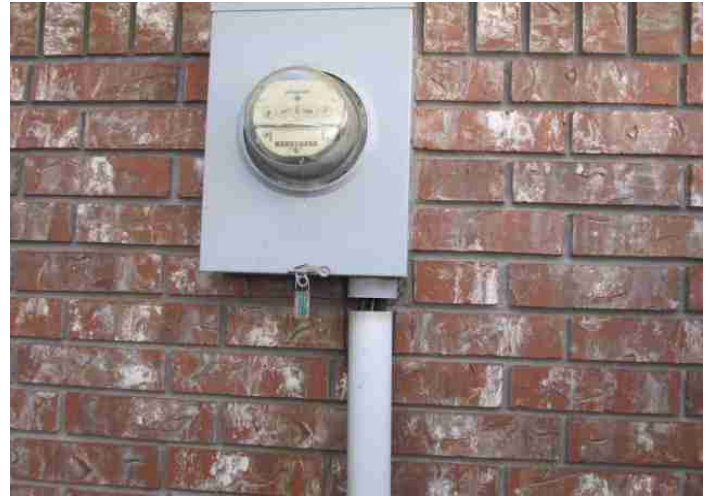
There is an electrical wire in the side yard that is not encased in conduit.

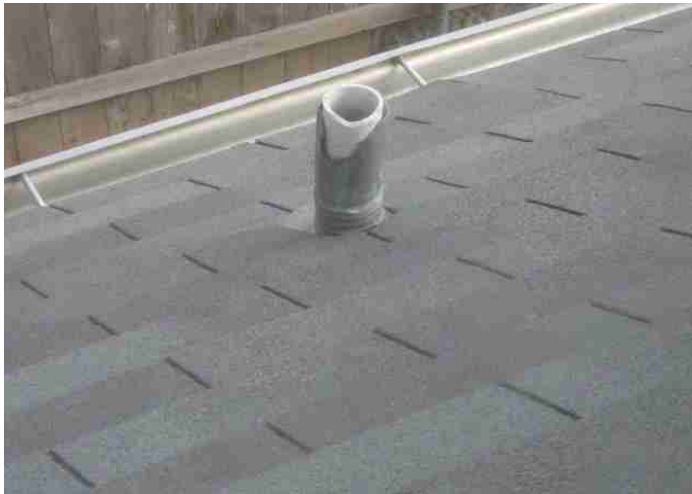
Several of the lead plumbing flashing's on the roof are deteriorated and should be replaced by a licensed roofing contractor to prevent leaks.

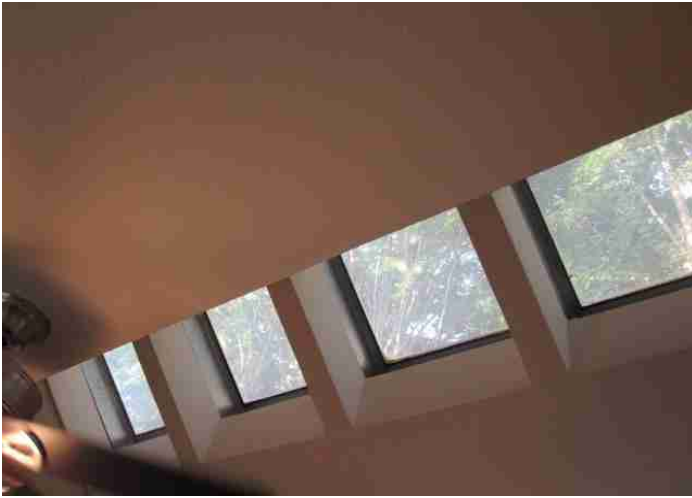
Skylights

The roof includes one or more skylights, which are notoriously problematic and a common point of leaks. There are different methods of installing them and, although opinions will vary, some methods are better than others. Therefore, it will be important to keep the area around them clean and to monitor them for evidence of leaks.

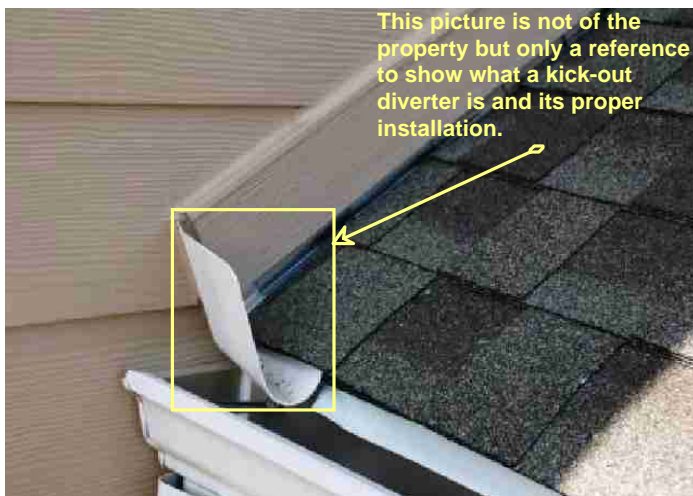
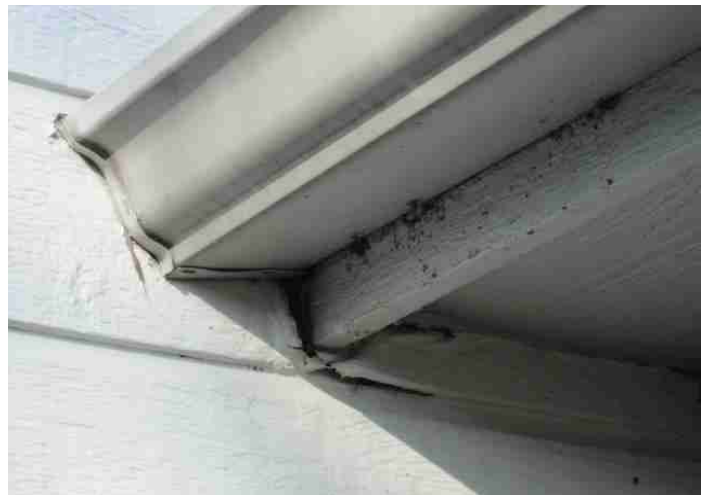
The gutters need to be cleaned and serviced to drain properly.

In homes where gutters die into the side wall of a home, there is the potential for moisture issues. Problems arise when rain runs down the roof along the side of the wall and into the gutter. If the water is not purposely directed into the gutter, water may seep between the gutter end cap and the wall. Often the siding is notched in this area leaving a small gap where water can make its way into the interior of the wall. To prevent this, a small piece of "L" shaped metal, called kick-out or diverter flashing is installed. This flashing slips under the wall flashing and then is angled out to direct water into the gutter instead of down the wall where it could possibly penetrate into your home and cause unseen moisture damage. The picture here shows what a typical piece of properly installed diverter flashing looks like.

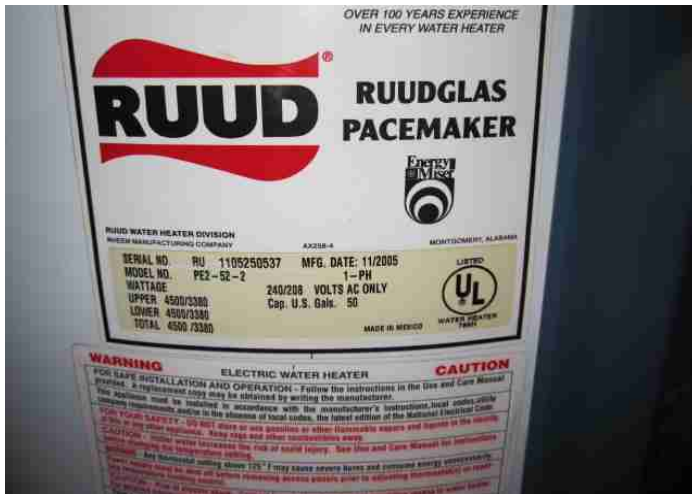
Age Capacity & Location *Informational Conditions*

The water heater is located in the attic. The 50 gallon unit was manufactured in 2005.

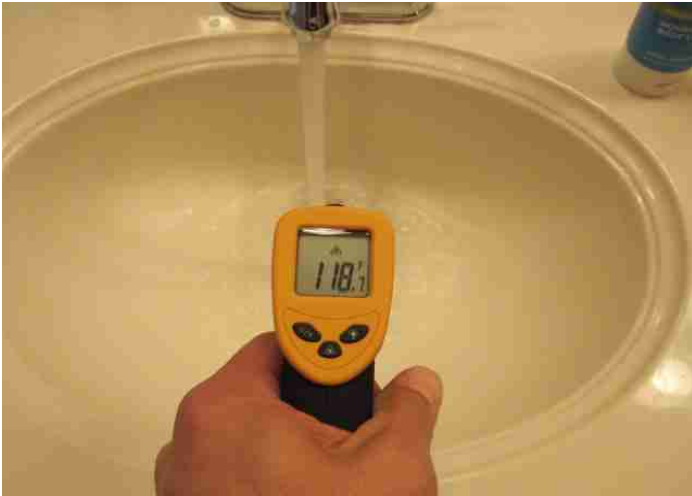
The water heater is functional. The photo if attached shows the hot water discharge temperature from a randomly selected faucet.

According to the US Department of Energy, a temperature of 120 degrees at the tap is adequate for most household chores with a minimal danger of scalding and maximal energy efficiency. However, that is the temperature at the tap, not in the tank. Tank temperature should be no less than 130 degrees to prevent bacterial growth.

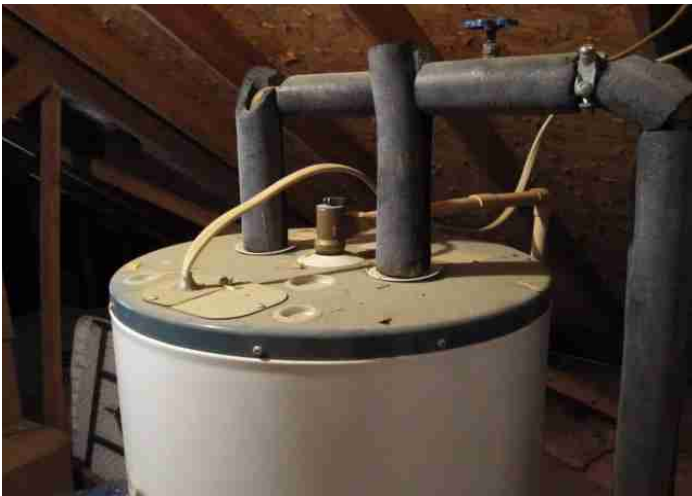
The shut-off valve and water connectors are in place and presumed functional.

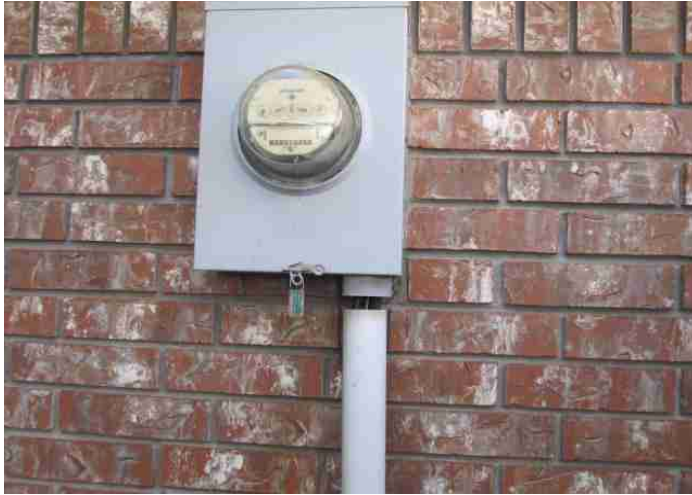
The main conductor lines are underground, or part of a lateral service entrance. This is characteristic of modern electrical services but, inasmuch as the service lines are underground and cannot be seen, they are not evaluated as part of our service.

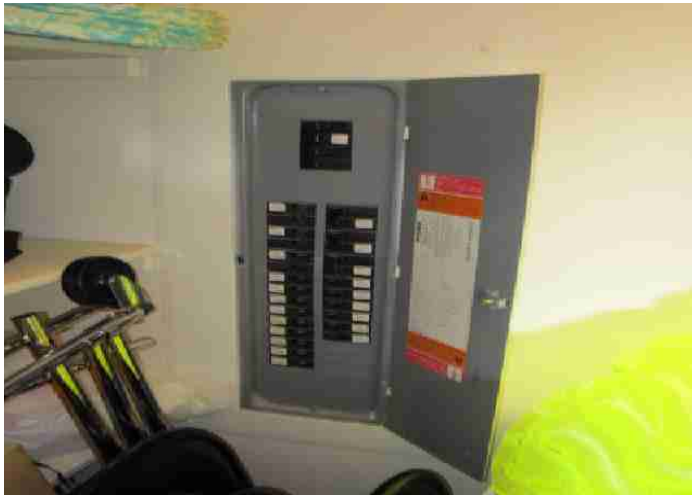
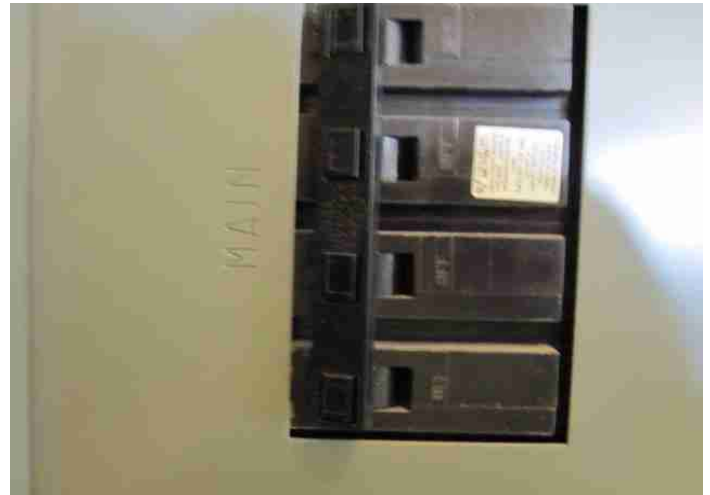
Panel Size & Location

The residence is served by a 150 amp, 240 volt panel, located in the garage.

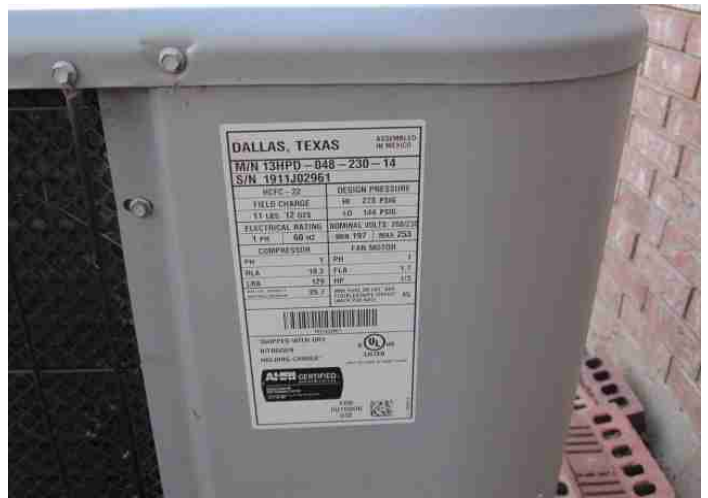
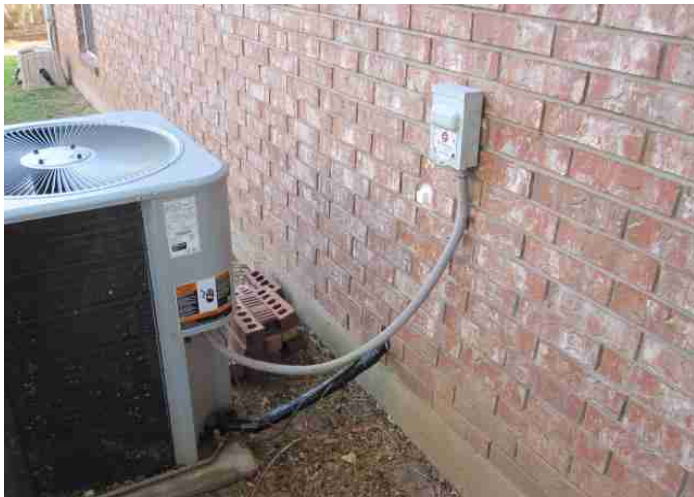
Central heat and air-conditioning are provided by a heat pump, with an air handler located in attic. The heat pump was manufactured in 2014. The air handler was manufactured in 2014.

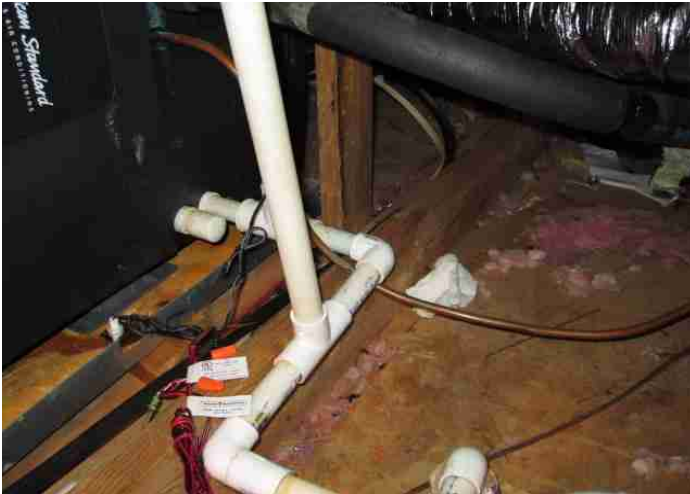
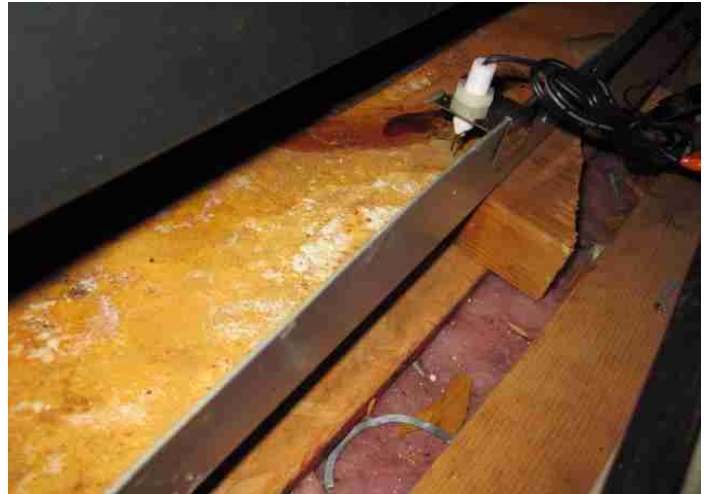
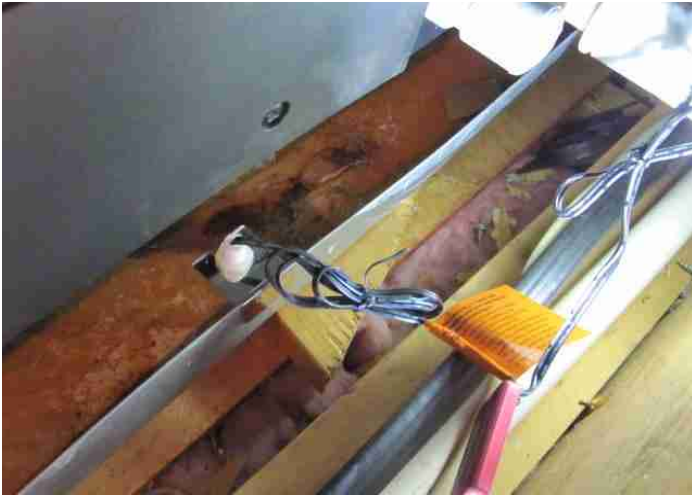
The drip pan appears to have held water. The photo shows the attic drip pan. The areas that are discolored indicate where water has stood in the pan. I recommend that you monitor this pan frequently during the summer months. If water is found in the pan, service will be necessary.

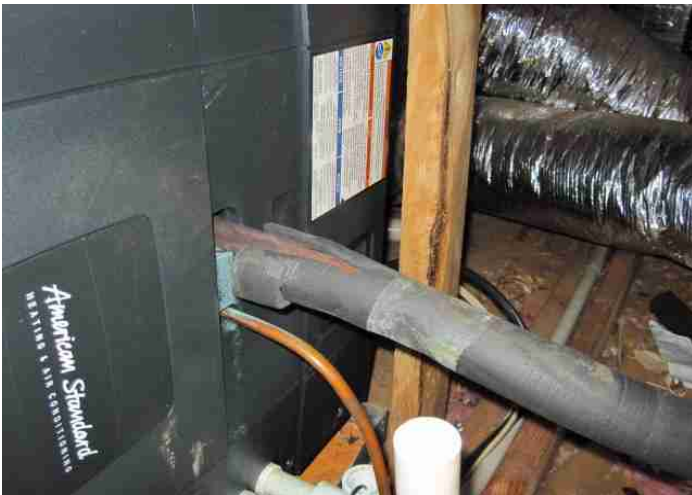
Insulation is missing from the refrigerant lines at the evaporator coil, which will allow condensation to form and drip, and should be installed.

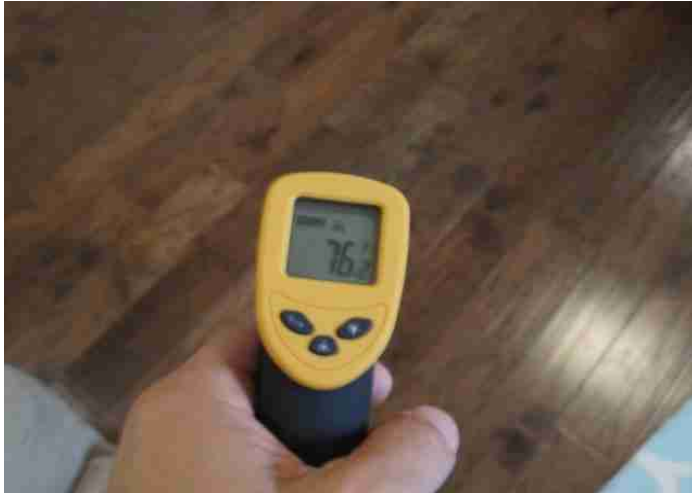
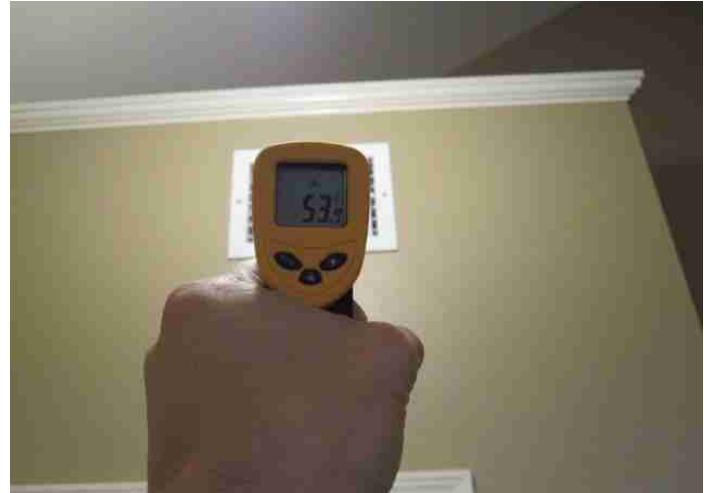
Differential Temperature Readings

The air-conditioning responded and achieved an acceptable differential temperature split between the air entering the system and that coming out, of fifteen degrees or more.

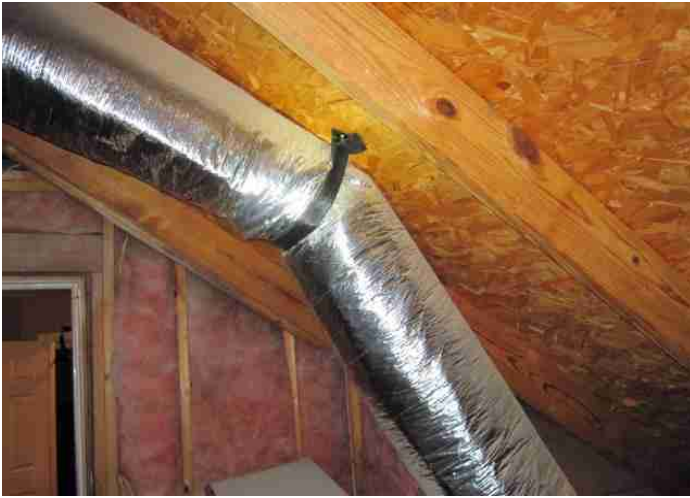
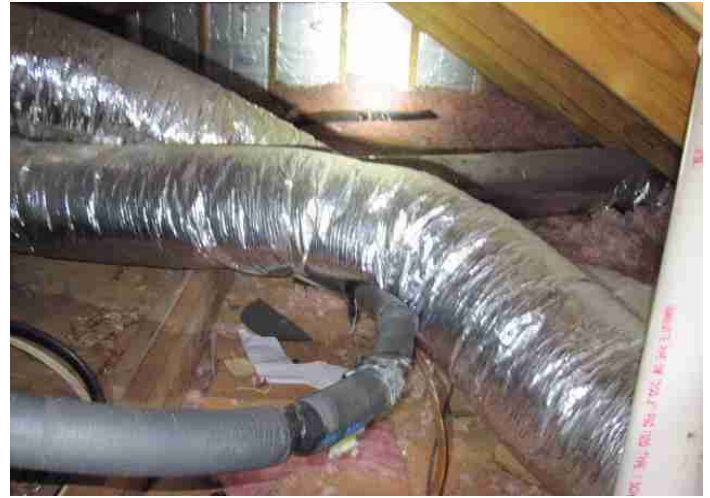
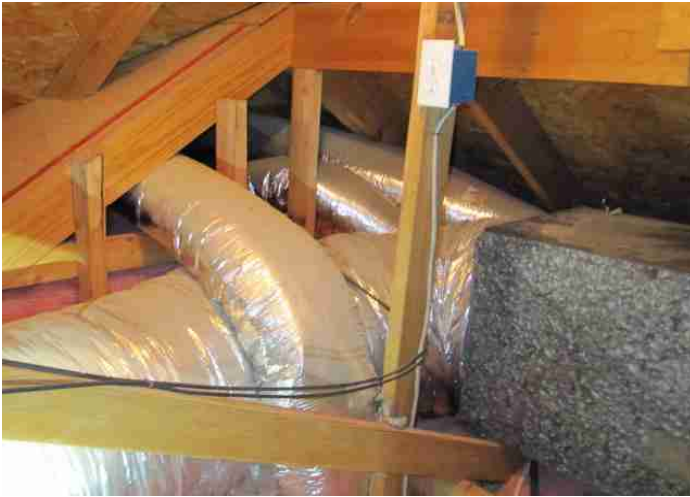
The visible portions of the flexible HVAC ducts appear to be satisfactory. They are a modern flexible type that are comprised of an outer plastic sleeve and a clear inner liner that contains fiberglass insulation.

Significant portions of the ducts are concealed and cannot be viewed.

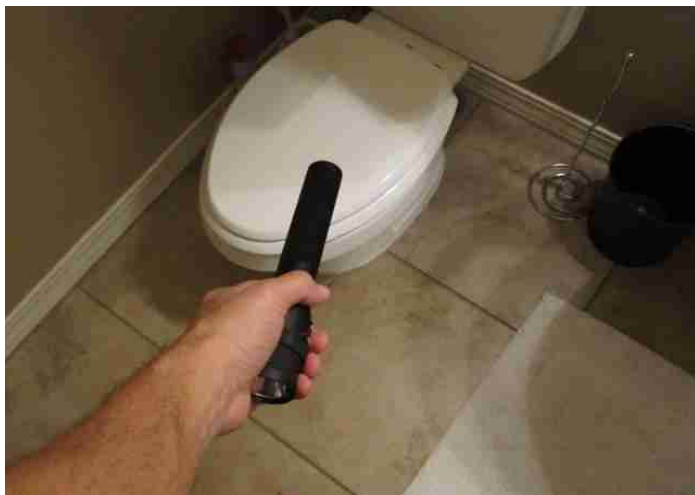
The toilet is loose, and should be secured by a licensed plumber. This toilet is installed on a ceramic tile floor and likely only needs to be shimmed and caulked. I recommend service by a qualified, licensed and independent plumber.

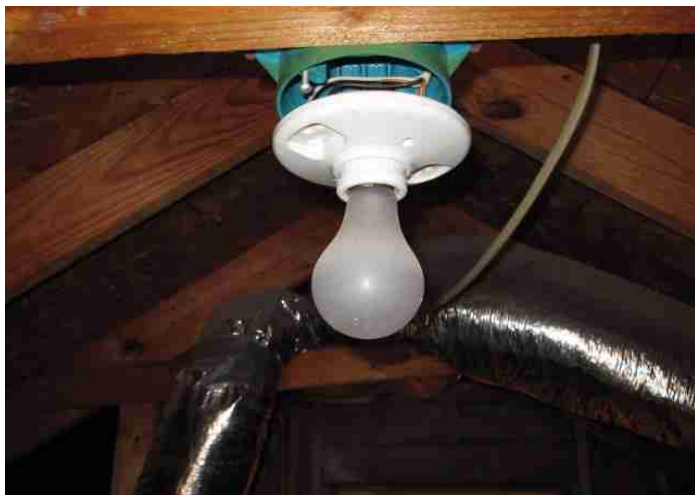
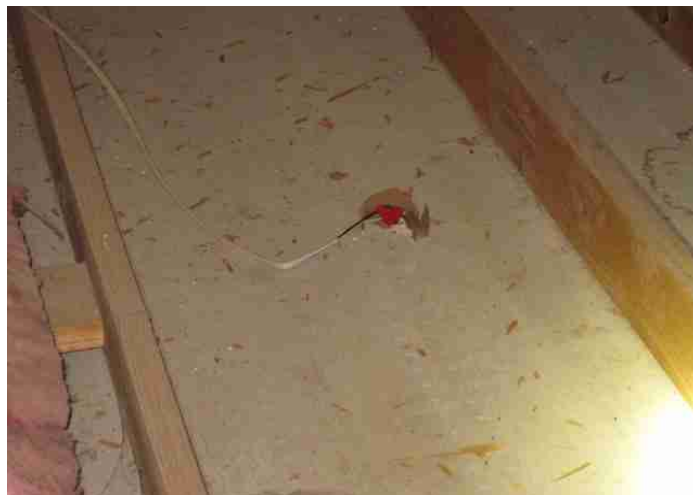
There is an open electrical junction box, which should be sealed so that any arcing or sparking would be contained within the box.
